Manhole Inspection Summary

Manhole # S43CC_105MH

Record Plat: **43CC** Node: **105** Status: **New Manhole (Not in GIS)** Insp Date: **11/20/08 12:00 AM**

Location Address: **1715 eager st**

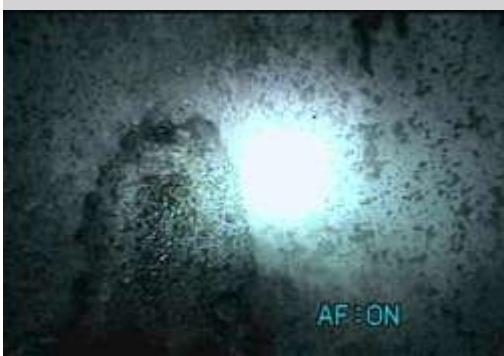
Defect 5

Infiltration: ☐ None ☐ Joint ☒ **Cracks** ☐ Mortar ☐ Roots ☒ **Wall**

barrel infiltration

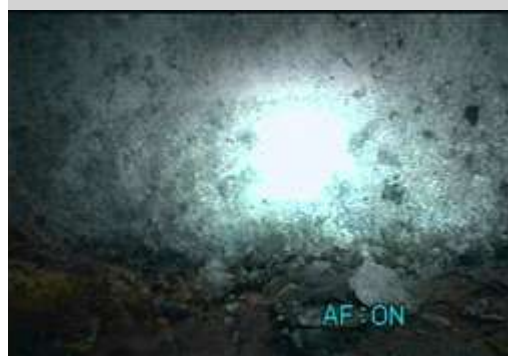
Defect 4

Condition: ☐ Sound ☐ Cracked ☐ Root Intrusion ☐ Deteriorated ☐ Leaks ☒ **Debris**

bench debris

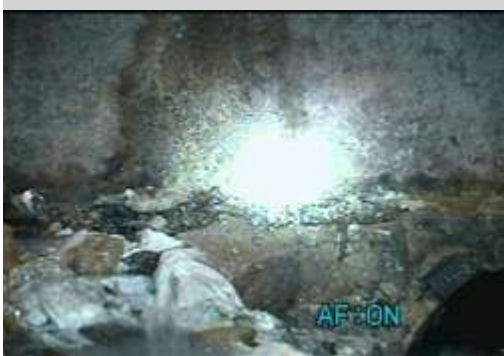
Defect 3

Condition: ☐ Sound ☐ Cracked ☐ Root Intrusion ☐ Deteriorated ☐ Leaks ☒ **Debris**

channel debris

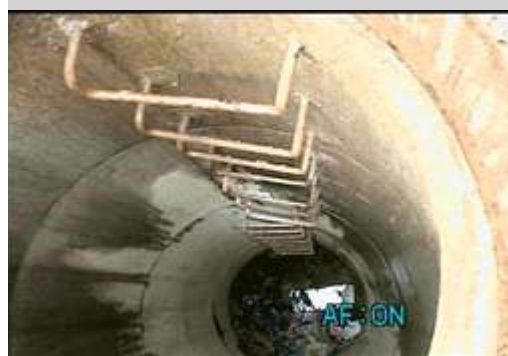
Defect 2

Infiltration: ☐ None ☒ **Joint** ☐ Cracks ☐ Mortar ☐ Roots ☐ Wall

Count: **15** Missing: **0** ☒ **Corroded**

chimney and corbel joint infiltration, corrosion step

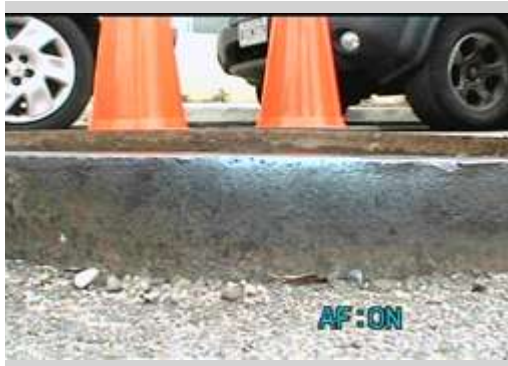
Defect 1

Diameter: **32** (in.) Length: **0** (in.) Dist A/B Grade: **2** (in.)

above grade
